Subject: IR Reflection Issues

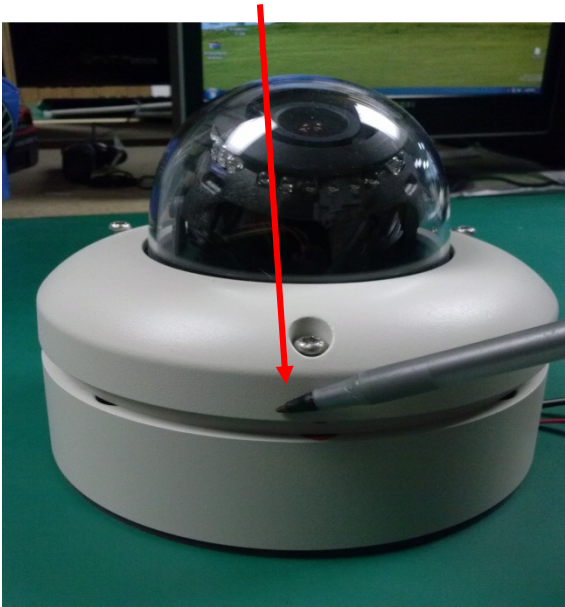
- The dome cover is not bolted in tight enough.

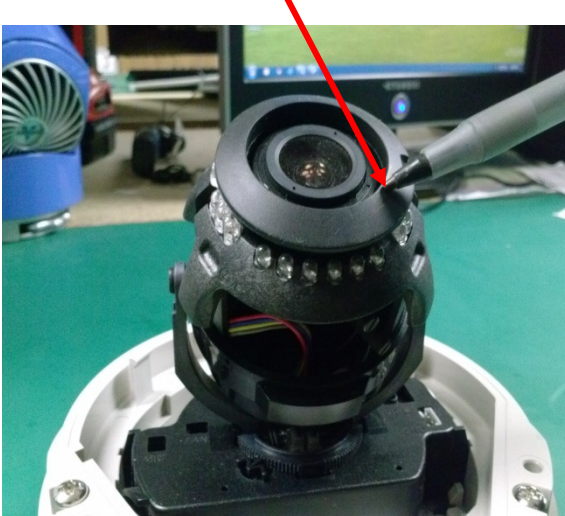
- The rubber or plastic seal between the lens and the dome cover is missing or not flush against the clear dome cover.

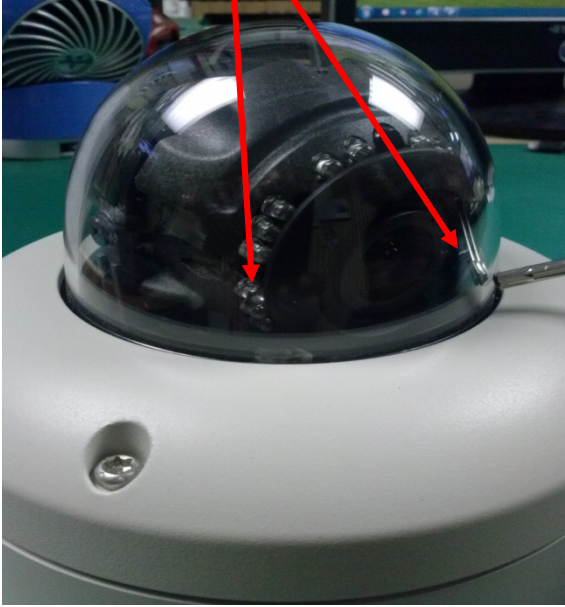
- The Lens is exceeding the recommended tilt causing the IRs to hit the lens cover (see user manual for tilt)

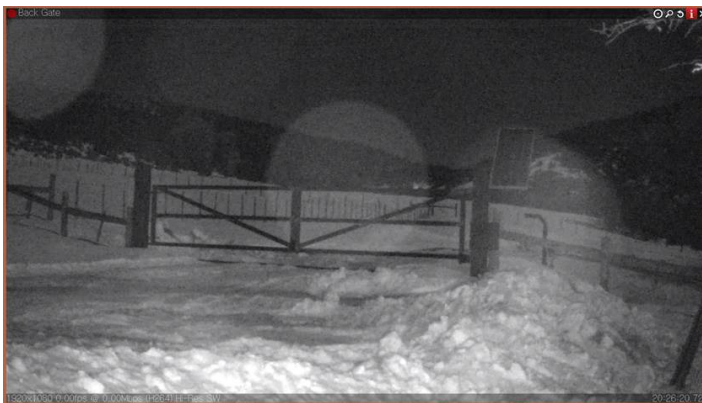
- Accumulated dust, snow or raindrops will reflect infrared, causing a blurred, foggy ring in the image

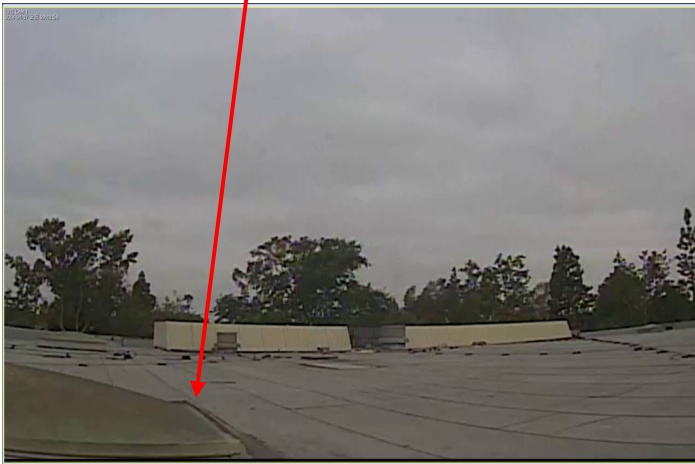
- A reflective surface near the security camera that is reflecting the IR light back into the camera.
Ex: Day shot (reflective object)

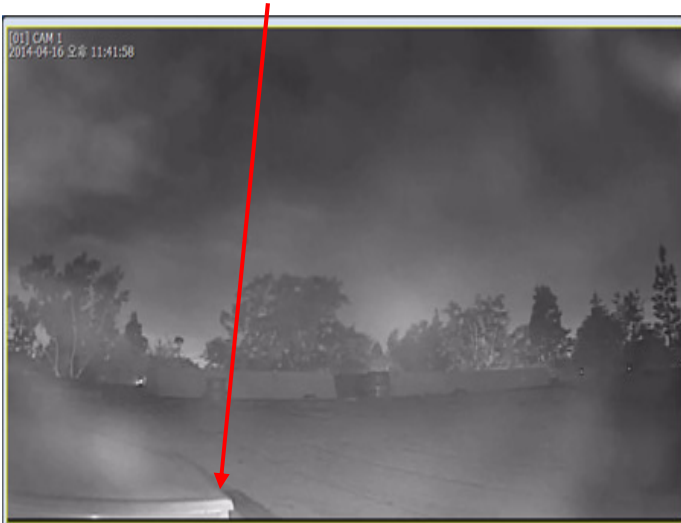
Ex: Night shot with glare from object
